F A X C O V E R S H E E T

RE: File documents re. subsurface conduits

AMERICAN GLUE & RESIN CO.

PHASE II

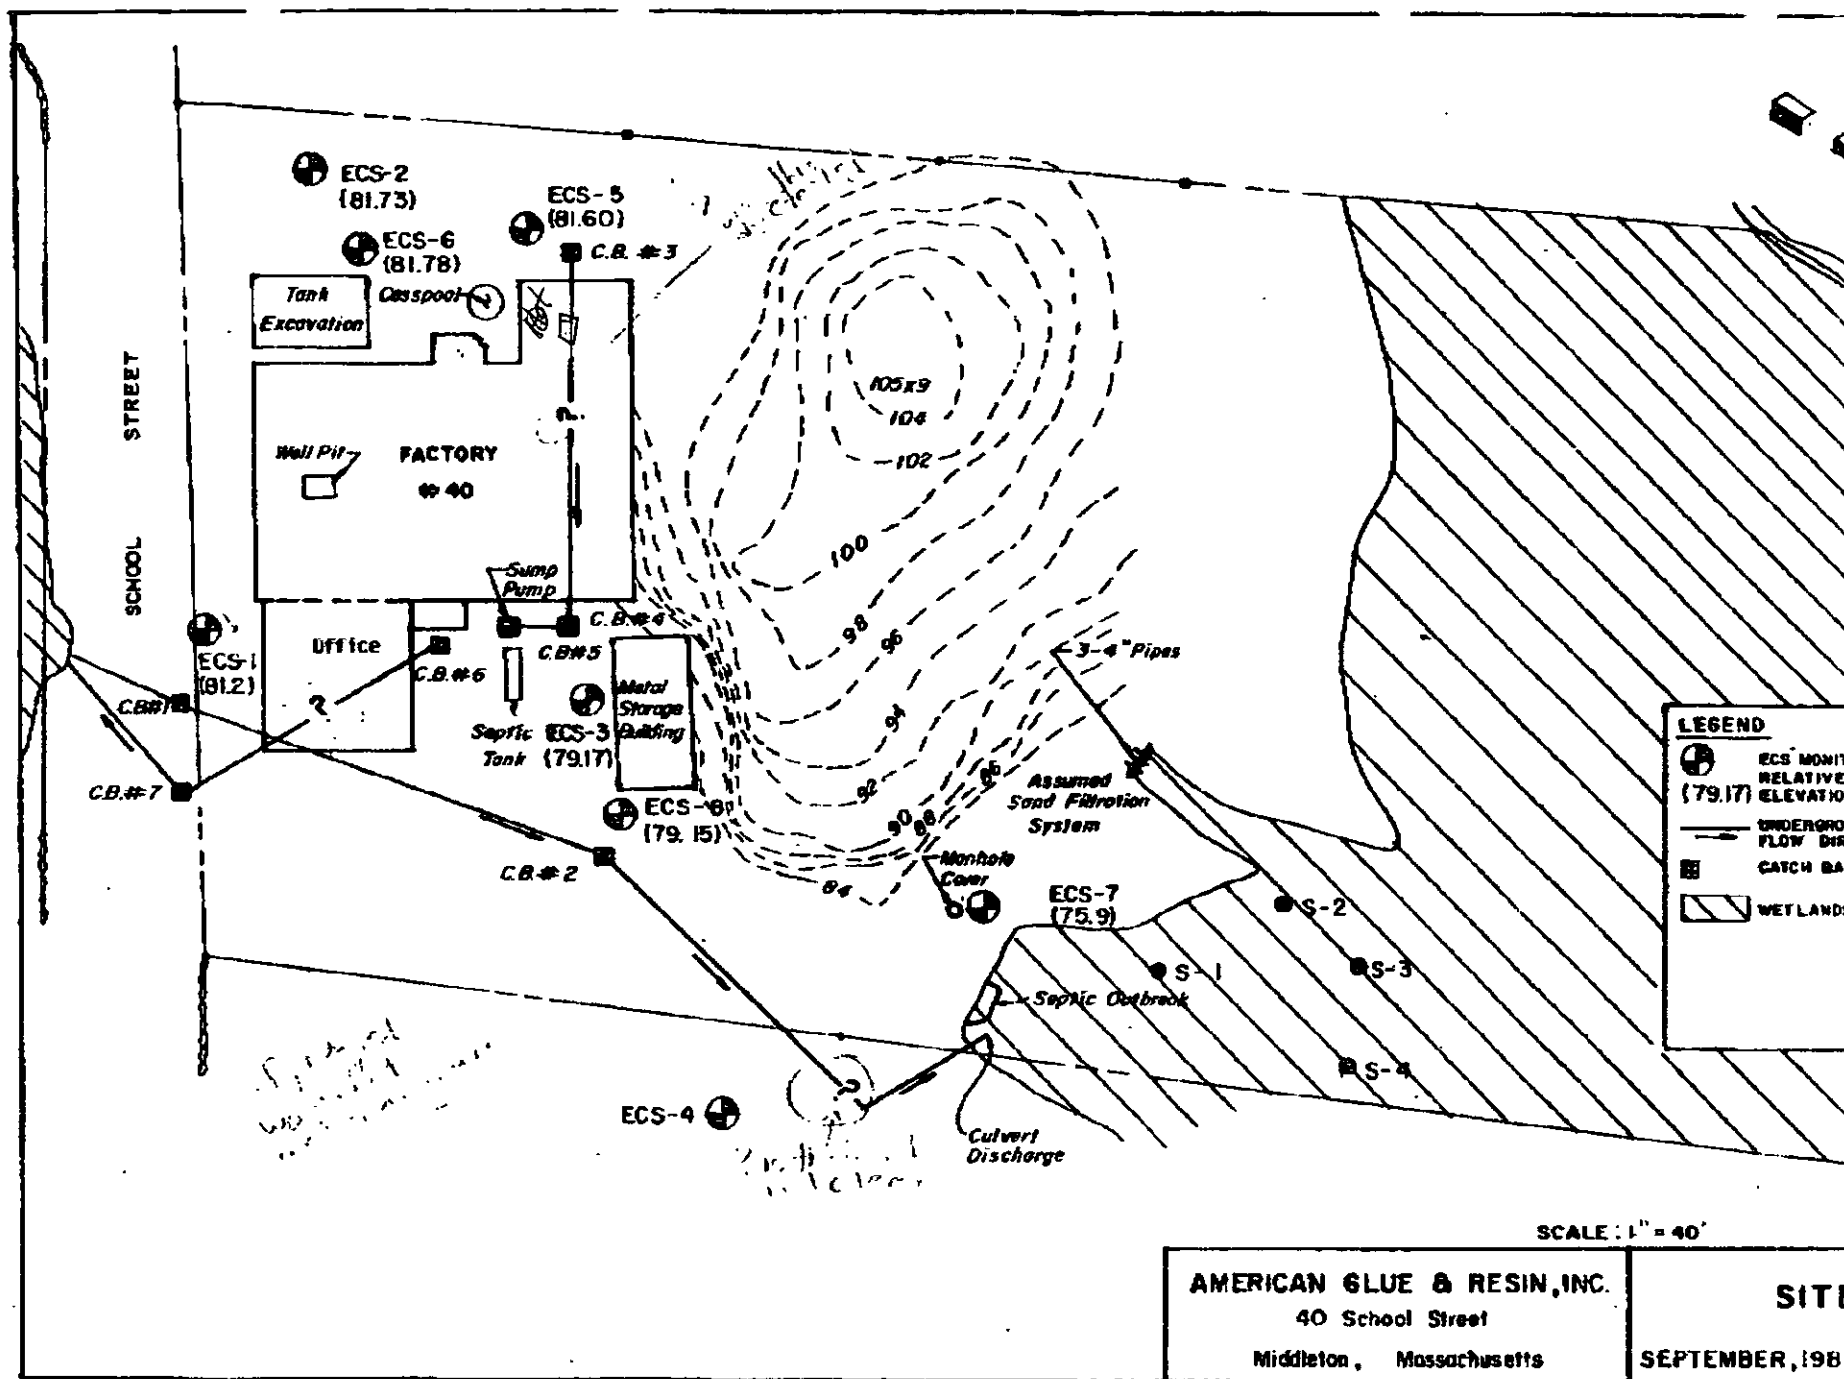
AMERICAN GLUE & RESIN, INC. 40 School Street Middleton, Massachusetts	SITE SEPTEMBER, 1987
--	--------------------------------

A 12-inch corrugated metal pipe carries water above elevation 81.7 feet, USGS Datum, from the off site pond, on the south side of School Street to the wetlands associated with Boston Brook on the northwestern section of the property. It is assumed that this pipe was installed by the town to alleviate flooding problems on School Street. Associated with this pipe are a catch basin located in School Street, and a catch basin to the east of the on site metal storage shed. These catch basins are designated as no. 1 and no. 2 on the basic layout of this system as shown

on Figure 2. During all inspections water within this system was flowing continuously at a high velocity. The interconnections of this system were confirmed by dye tracing.

Currently an on site storm water drainage system exists. However, based on observations made the system appears inefficient due to improper invert elevations. The catch basins contained water but a minimum amount of flow was observed. The piping diagram shown on Figure 2³ was drawn from information obtained from conversation with employees and observation of the physical layout of the system. Based on this available information the system seems to begin at catch basin no. 3 located near the western corner of the building. The drainage pipe supposedly continues through the building where the line then enters catch basin no. 4 on the east side of the building. This catch basin no. 4 was sealed in November, 1986 at the request of the DEQE. A pipe leading from this sealed catch basin enters another catch basin no. 5 which contained a sump pump which would periodically discharge to the ground surface. It is not known what if any interior drains, which were sealed in November of 1986, were connected to this drainage system.

The second section of the system begins at catch basin no. 6 in the loading dock area. It is assumed

that basin no. 6 is connected to a catch basin no. 7 within School Street, which discharges to the pond across School Street. No dye testing to confirm the flow or drainage of this system could be performed as catch basin no. 6 was plugged and filled with sand.
